# **Structural Faults & Repair-2008**

**12th International Conference**

# THE SOLBRITO VIADUCT: INSPECTION, ANALYSIS AND REHAB

Maurizio Deiana  
S.A.T.A.P. S.p.A.  
V. Bonzanigo 22,  
10144 Torino  
Italy

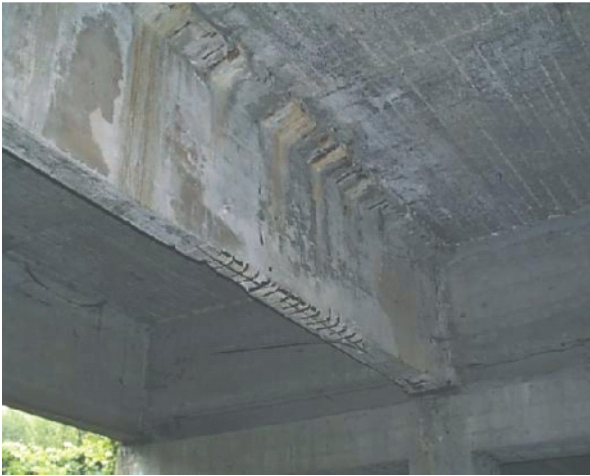
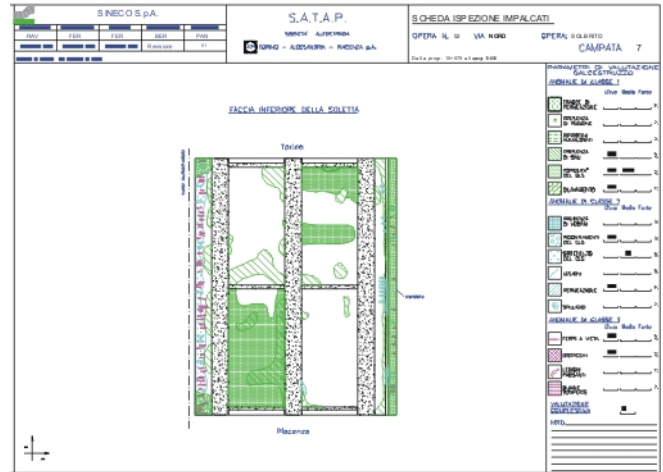
Fig. 1 Solbrito visual inspection of the deck and "damage data sheet" recorded by the inspector

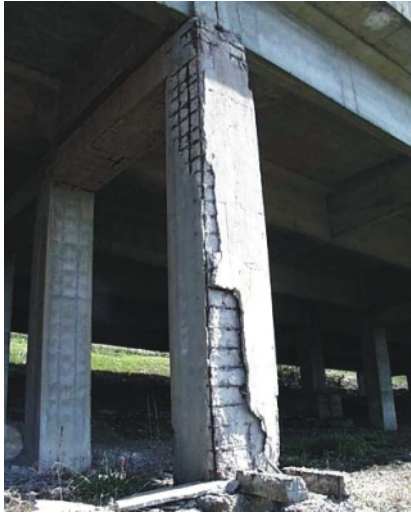
The analysis of annual inspections, as explained before, permitted to indicate and characterize all the deteriorations of the concrete material (carbonation, chlorides penetration, mapping of degradation). The bridge presented phenomena of water leakage coming from the upper road, in particular next to the joint, diffused break up of concrete bar cover and steel bars revealed corrosion in advanced progress. In particular the steel corrosion was visible on the lower surface of the decks and on the pillars and, in minor measure, on the beams (see Fig. 5 and 6).

Fig. 5 Concrete bar cover damage

The piers presented general surface degradation of concrete with spalling of re-bar cover. The bearing supports were deteriorated and therefore badly functional. In particular it was possible to observe the corrosion for most of the steel plate bearings and leakage of lead layer for some of them.

The measure of the depth of carbonation ( $>25$  mm) in the concrete reveals that the elements more involved in the phenomenon were the decks and piers, and it was reasonable to conclude that the steel bars are in a visible state of corrosion.

The concrete piers deterioration required a radical operation of restoration, after thorough selective hydro-demolition of all parts (thickness of 5-6 cm), between widening the former rectangular cross-section to a new circular Ø1400 wide, with adequate additional steel bars (for seismic reinforcing and deck uplifting) properly linked to the existing foundation and inserted in a new concrete casting.

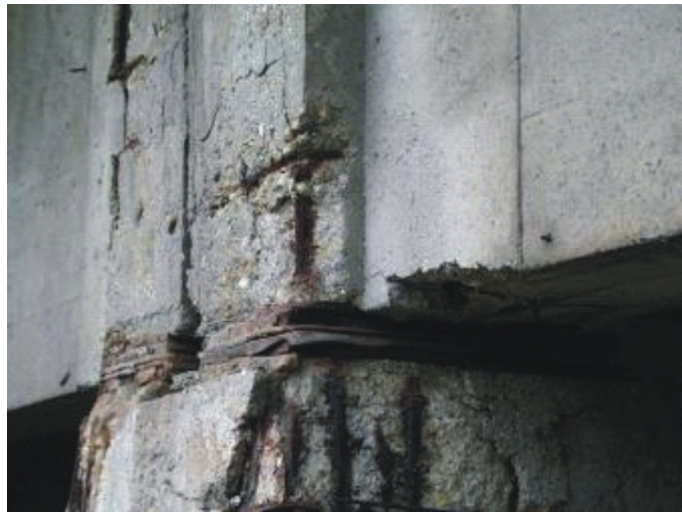
Fig. 6 Existing bearings degradation

The design has foreseen to replace the existing beams bearings, dating back to the period of construction, with modern ones in steel-PTFE in order to ensure the perfect absorption of thermal expansions and movements induced implementing the cinematic connection; three types of bearings were used: abutment fixed bearings, unidirectional and multidirectional bearings on the pylons.

The replacement of old bearings took place after the controlled lifting operation, equipped with automatic control unit, that allowed the contemporary lifting of the beams constituting, through the use of boxes on enlarged piers, the subsequent removal of existing bearings and the positioning of the new ones.

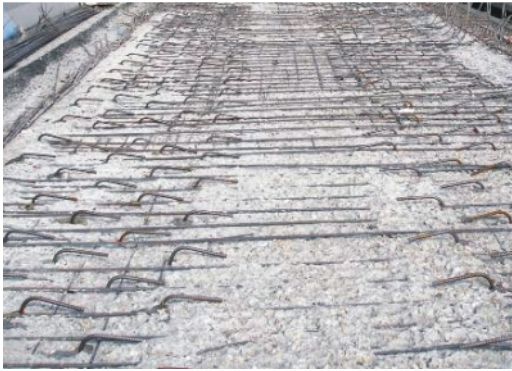
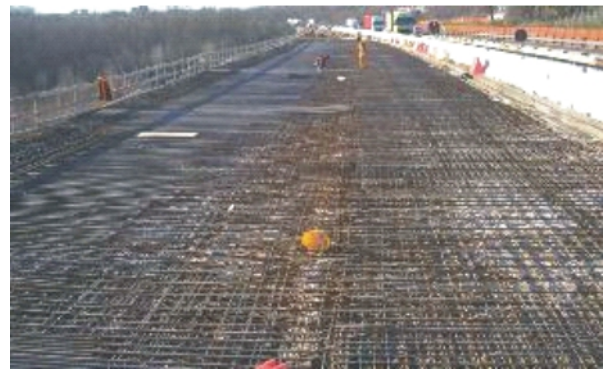
Fig. 12 Steel bars casting and connectors

The restoration of the existing part of the Solbrito viaduct has concerned: removal of the existing paving, hydro-demolition of diffused selective upper surface of the deck, reconstruction with laying down new reinforced bars and finally cast of concrete with elevated resistance.

The slab was strengthened in both longitudinal and transversal side with steel bars and with a uniform (60×60cm) distribution of steel connectors like “Nelson bolts” (Fig. 12) to provide a shear contribution between new and existing slab concrete; the thickness of new slab was increased from 12 cm on top up to a 26 cm.

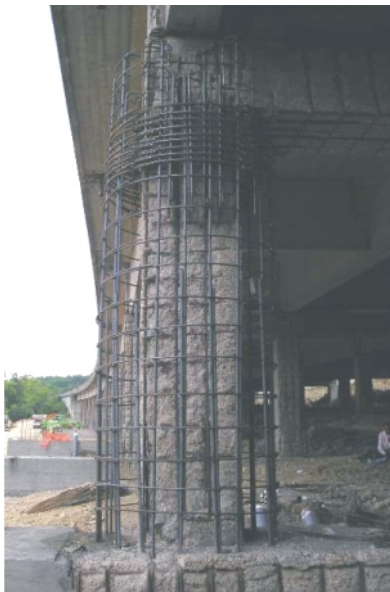
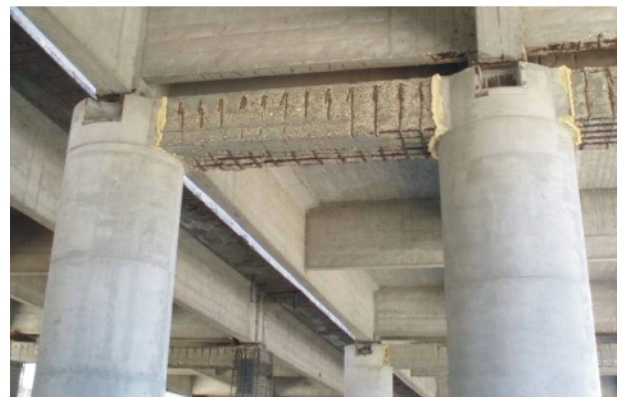
Fig.13 Piers rehab

Selective hydro-demolition was used for the restoration of the transversal beam on the top and bottom of the piers, sandblasting for all inconsistent parts and cleanliness of the steel bars, tixotropic mortars (high flow behaviour and compensated shrinkage) and final acrylic painting as shown in fig. 13.

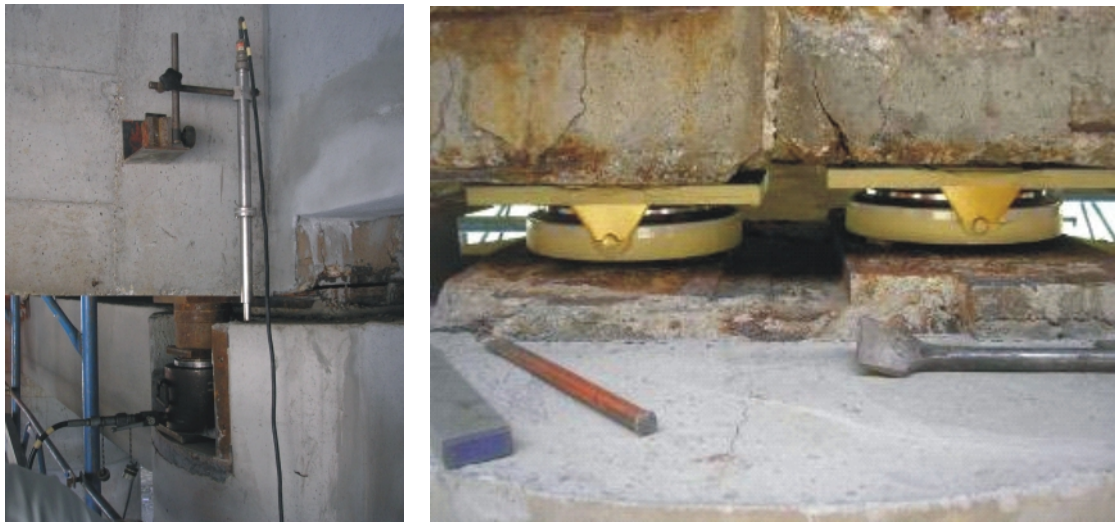
Fig 15 Unit for lifting with hydraulic jackets and new bearings
