Structural Faults & Repair-2008

SEISMIC RISK ASSESSMENT AND RETROFIT DESIGN OF TWO EXISTING REINFORCED CONCRETE VIADUCTS

KEYWORDS: Existing bridge assessment, HDRB isolation device, seismic vulnerability, seismic isolation, response spectrum, retrofit.

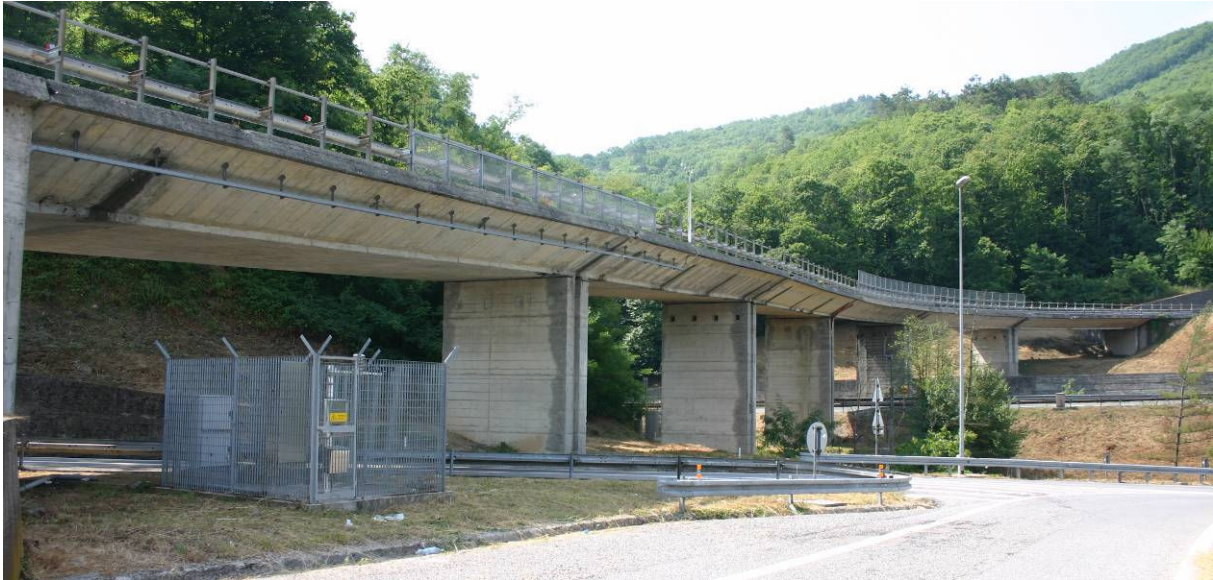
Fig. 1. View of the "Carrodano" viaduct (neighbouring the Levanto town, Liguria, Italy)

The first viaduct (Fig. 1), generally known as "Carrodano" viaduct, is a reinforced concrete bridge overpassing the national highway A16 Genova-Livorno near the town of Levanto (a well-known seaside resort, west of La Spezia in the Liguria region, Italy).

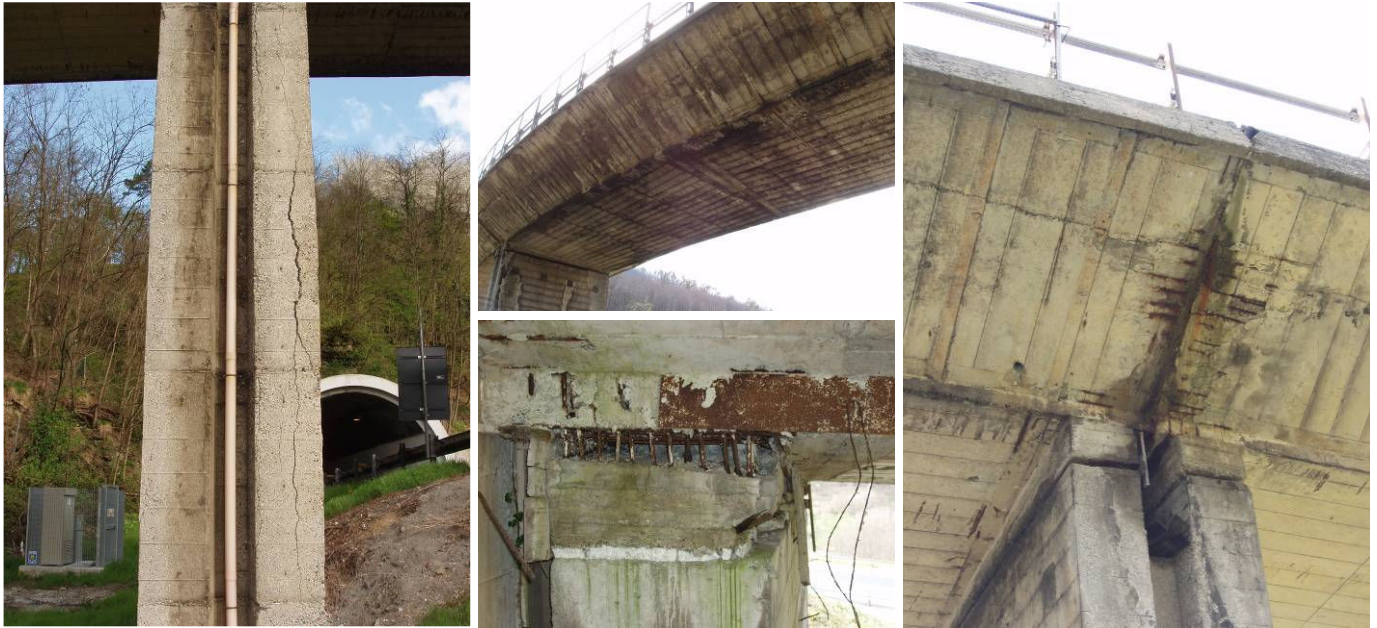
Fig. 4. "Carrodano" viaduct: structural details and examples of local damage

The evaluation of the general state of preservation of the structure was carried out by traditional on-site inspection procedures. Diffuse detachment of the coverage, reinforcement corrosion and material washing are the main damage factors affecting the structure (Fig. 4). The decay is especially localised in the following structural elements: (a) the external lateral sides of the piers and of the pulvins, where the coverage is widely detached due to the water washing; (b) the parts of the lateral tie beams close to the drain-off bores and to the expansion joints; (c) the deck areas close to the expansion joints.

The decay seems mainly caused by the concrete carbonation and by the water washing dripping from the deck, due to the ineffective drain-off system and to the pavement joints.

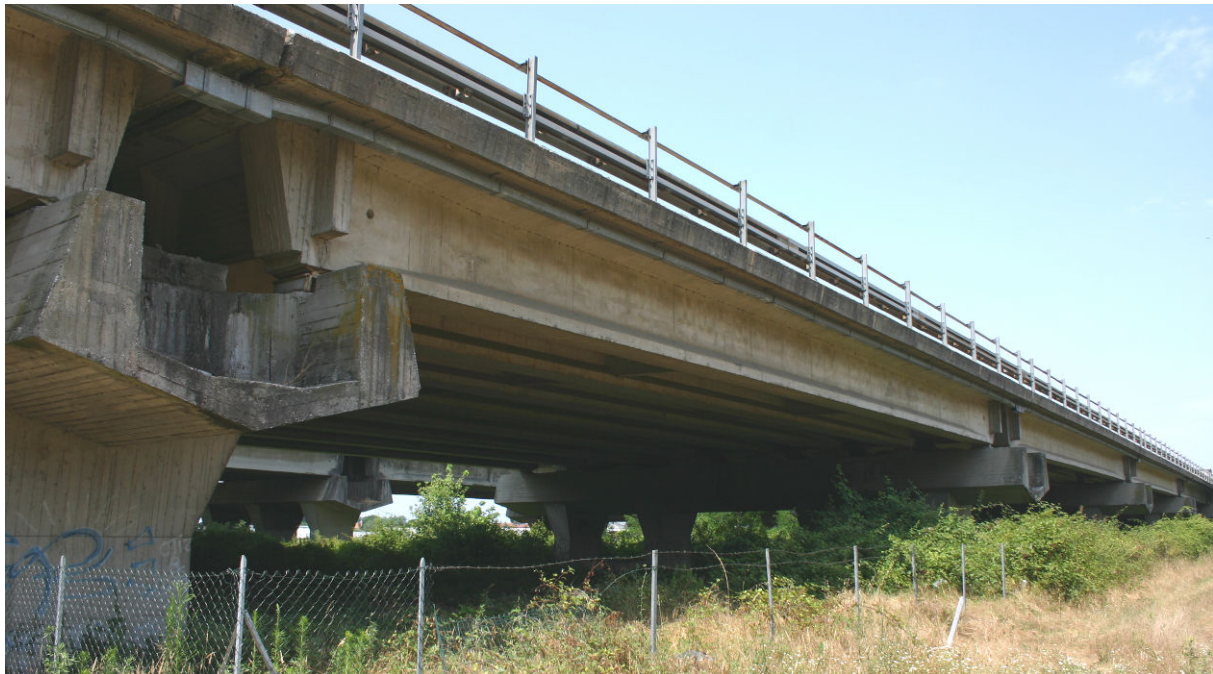
Fig. 6 Partial view of "Torre del Lago" viaduct (neighbouring the Viareggio town, Tuscany, Italy)

supported spans, for a total length of 604.00 m (Figs. 5-6).

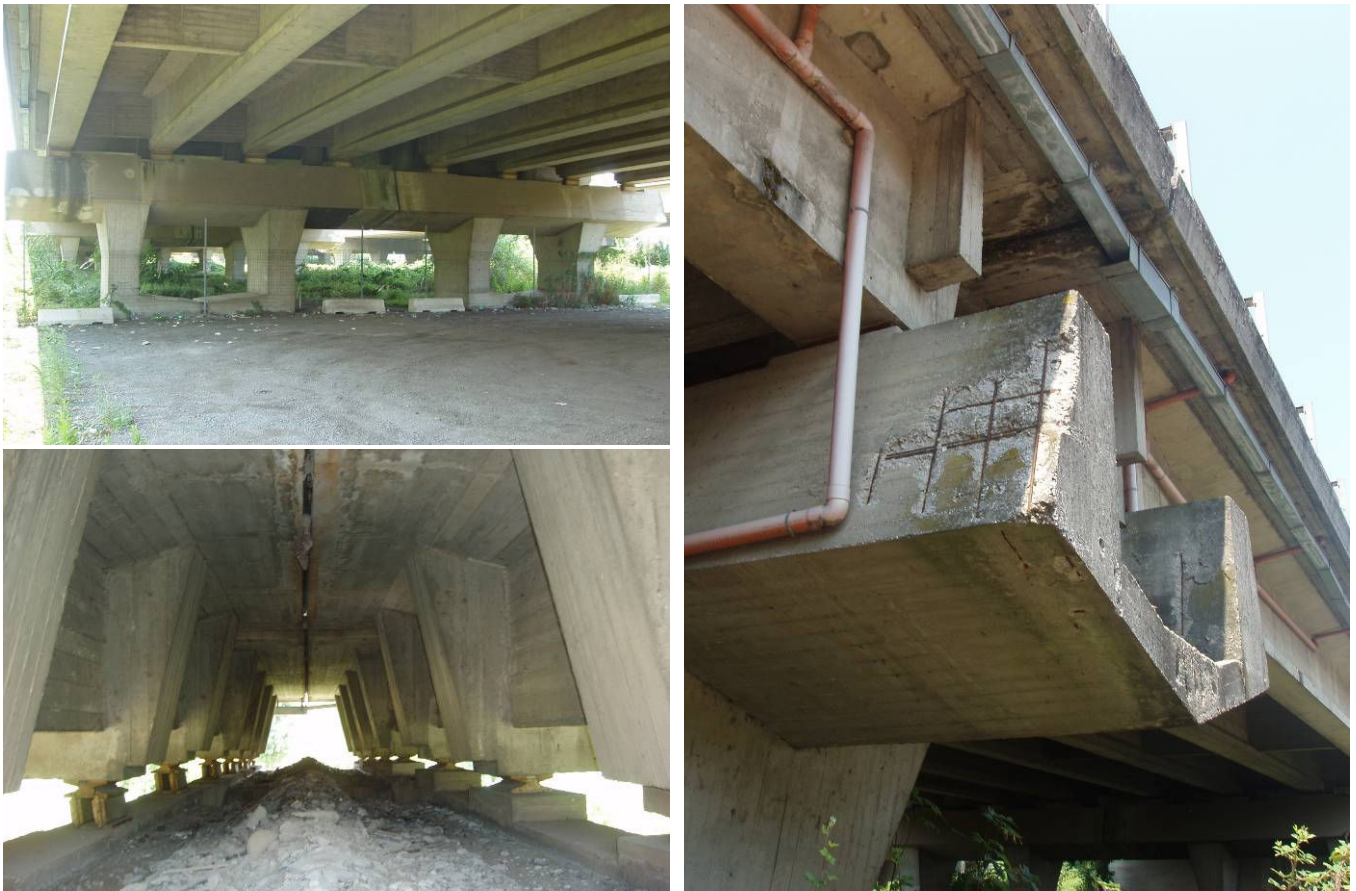
Fig. 8. "Torre del Lago" viaduct: structural details and examples of local damage

The deck of each span (Fig. 7) is 11.50 m wide and consists of a cast in place R.C. slab (20 cm high) supported by 4 longitudinal girders and 4 transverse floor beams (Fig. 8). The distance between the axis of bearings (clear span) is 29.00 while the overall span is 32.00 m.

The bearing (fixed and sliding) consists of steel elements characterized by diffuse corrosion. The piers are composed by two short rectangular elements (with dimension of $2.40 \times 0.90 \text{ m}^2$, Fig.8) supporting a massive pulvin beam (Fig. 8), about 12.00 m long.

Also in this case, accurate visual inspections led to the evaluation of the general state of preservation. As it has to be expected, the main damage factors affecting the structural elements are diffuse detachment of the coverage (especially in pulvin beams, Fig. 8), carbonation of concrete, corrosion of reinforcement and bearings and material washing.
