# **Structural Faults & Repair-2008**

**12th International Conference**

# THE SOLBRITO VIADUCT: INSPECTION, ANALYSIS AND REHAB

Maurizio Deiana  
S.A.T.A.P. S.p.A.  
V. Bonzanigo 22,  
10144 Torino  
Italy

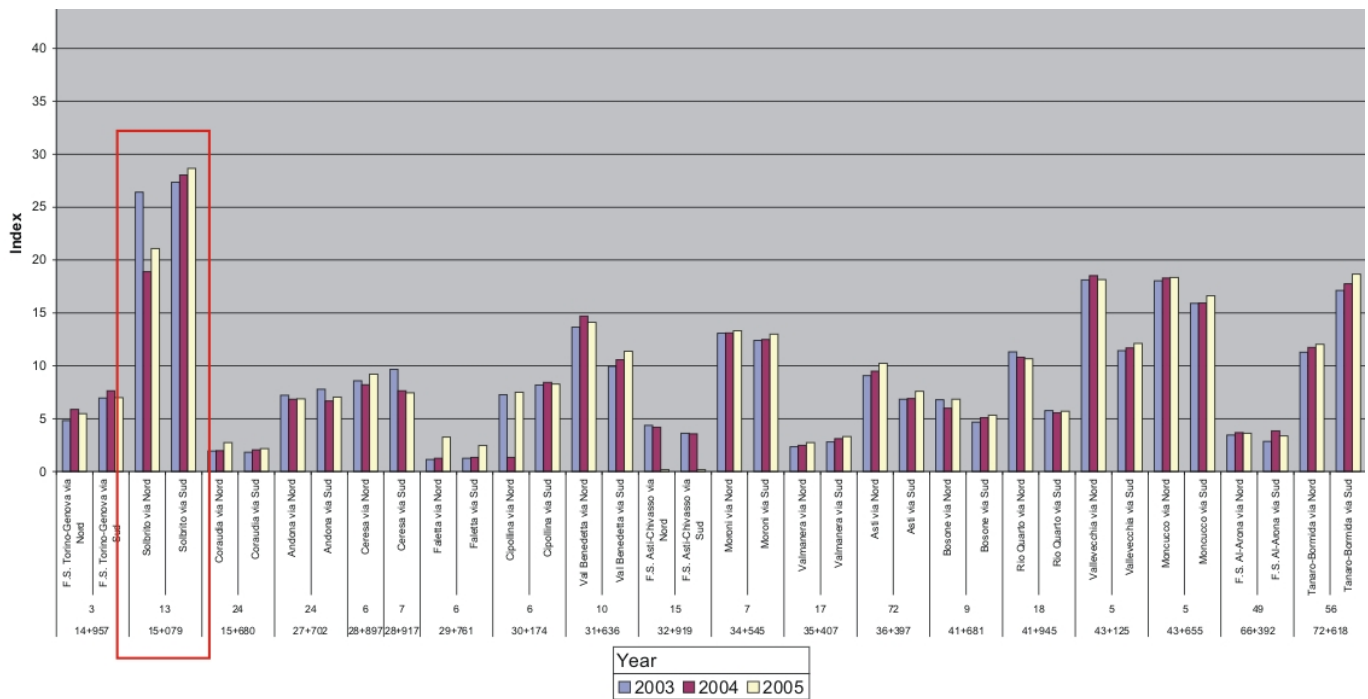
Fig. 2 Satap damage index trend

From the graphic above (Fig. 2) can be observed that the SOLBRITO viaduct was the first that needed a repair solution as more detailed in the BMS program defined. By this examination Sineco in according with the road owner started the design phase.

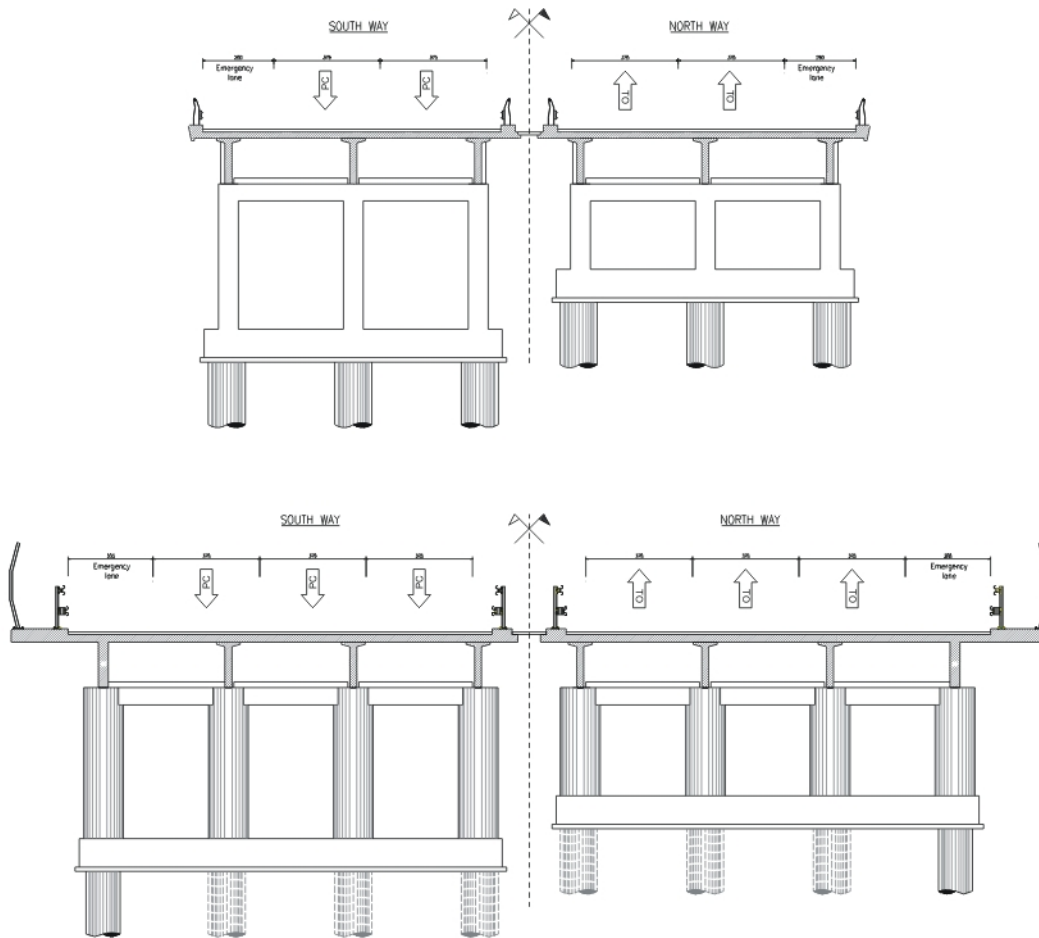
Fig. 7 Old and design bridge section

As described before the structural elements of this bridge had deep degradation problems in particular to pillars and bottom slab. Also from the preliminary structural analysis it was understood that the existing

structures were not able to support a widening of the lane using the same road section without a vast and difficult strengthening; the curbs also needed a heavy strengthening for supporting new guard rail.

The Road Owner decided for the solution described at the point c), widening the road section, for the following reasons:
